Energy Safety Canada is the national safety association for the oil and gas industry. We develop and support common industry safety standards, deliver effective learning systems, share data analysis and safety expertise with workers and employers, and advocate for worker health and safety. Our goal is the same as industry's – zero injuries, zero incidents.

# SHOULDER EYE BOLT FAILURE DURING EQUIPMENT LIFT

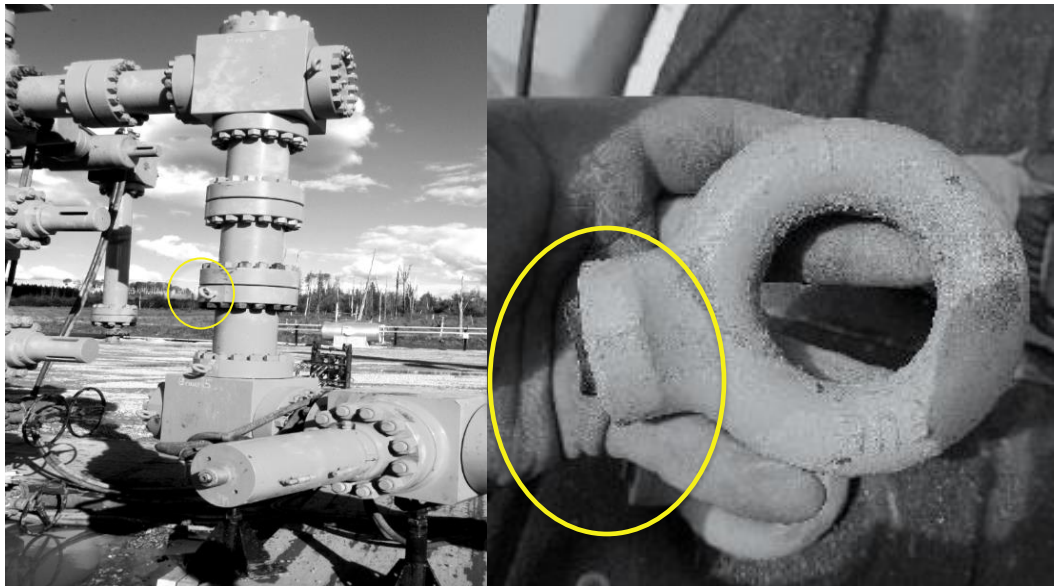
A fracturing ("frac")/ wellhead assembly was lifted approximately half an inch to adjust a support (levelling jack) stand. The lift was conducted using the horizontally - attached shouldered eyebolts on the equipment. The orientation of the eyebolts required an angular lift. The lift took place and the eyebolt shanks sheared off. The wellhead equipment was secured and no other damage occurred.

EYEBOLT LOCATED ON WELLHEAD

BROKEN PORTION OF EYEBOLT SHANK

The lift exceeded the angle load capacity which caused excessive strain on the eyebolts resulting in failure.

Angular lift significantly reduces lifting rated capacities.

- » Pre-plan each lift and understand engineering limitations of each component, including eyebolts
- » Before lifting, check with manufacturer specifications for rated load capacities and guidelines of eyebolt angle. Investigate appropriate methodology if using angled lifts. ie. safety swivel hoist rings

- » Shoulder eyebolts should not be used for angular lifts greater than 45°
- » Before use, inspect eyebolts for damage or alterations (grinding, nicks, gouges, distortions, worn, bent, etc.)

- » Check that eyebolts are stamped with name or trademark of manufacturer, size or capacity and grade. All information should be legible
- » Eyebolts should not be painted or otherwise coated when used for lifting; such coatings make it difficult to inspect for defects or wear indicators

- » Do not shock load eyebolts; use a gradual lift
- » No greater load should be applied to an eyebolt than the rated capacity
