Worker Seriously Injured During Water Transfer Pigging Operation

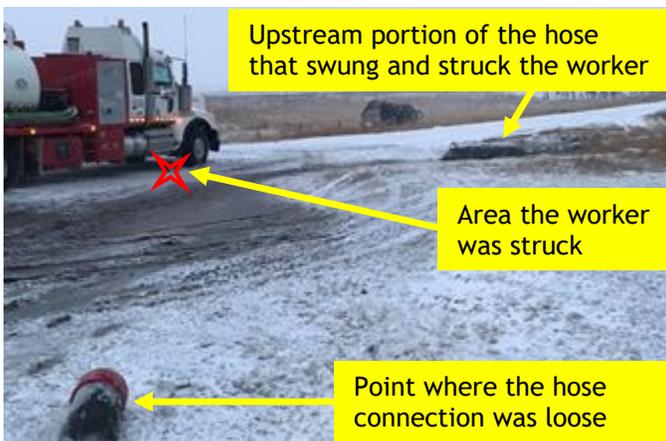
During pigging operations on a temporary water transfer line, a pig became stuck due to an ice blockage and pressure was trapped upstream of the pig. When it was freed, the pig and trapped pressure behind it traveled down the line causing a loose clamp to unfasten. The pressure release caused the disconnected hose to swing and strike a worker on the leg, causing serious injury.

View of the disconnected hose

- Proper heating operations were not in place. This resulted in ice/slush build-up in the line, which caused the pig to become stuck.
- A loose connection downstream of the stuck pig failed when the pig was freed, and pressure traveled downstream.
- Connection points in the water transfer line were not additionally secured with restraint devices (whip checks) to prevent movement in the event of a connection failure.

- Use heaters for all water transfer operations when there is potential for freezing conditions.
- Install restraint devices on all water transfer line connection points.
- Ensure pigging procedures adequately address and control line of fire hazards and are reviewed and understood by the entire crew.
- Ensure a supervisor is present and observing safety-critical tasks.
- A letter publicly acknowledging the incident and the actions taken is enclosed.
