Over Pressurized Piping Causes Line Failure

POTENTIALLY SERIOUS INCIDENT

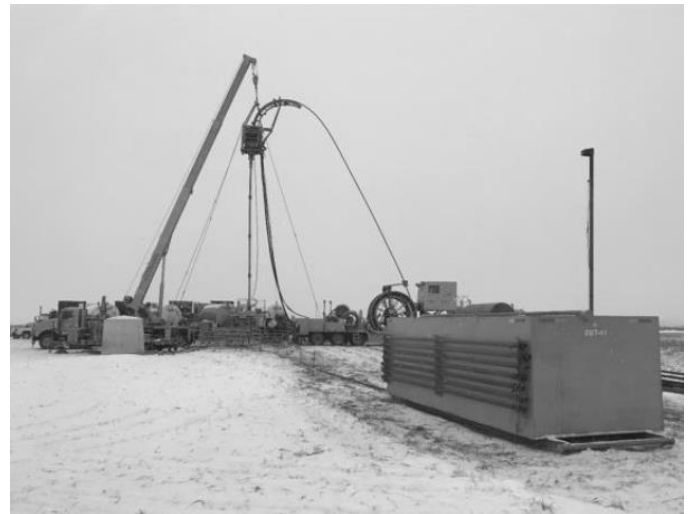
View of blowback piping and tank on the north side of site prior to overpressure event.

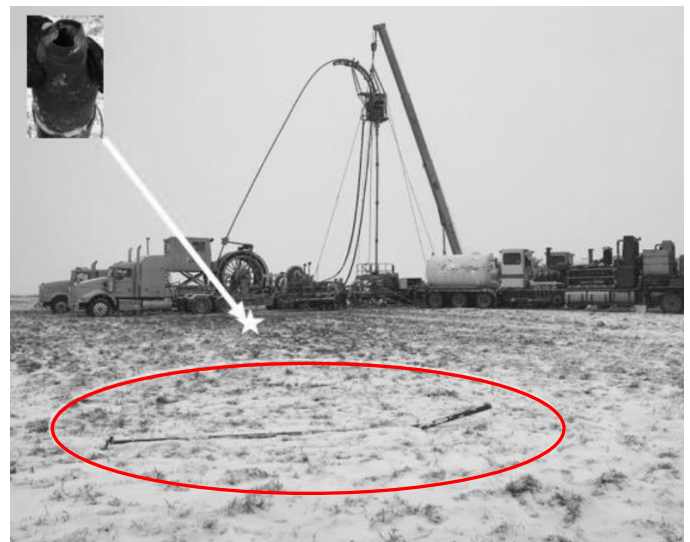
A coiled tubing crew was conducting pressure tests of the blowout preventer. Following a successful low-pressure test at 10 Megapascals (MPa) the line was bled down through two-inch diameter blowback piping to an open-top tank. This pressure was bled off without issue, confirming that the line was free of obstructions. At this time, a high-pressure test was conducted at 55 MPa. When the valve was feathered open to bleed off the pressure, a loud bang was heard, and the piping parted. Several workers were in the vicinity of the flying debris, but nobody was injured.

The blowback piping was over pressurized. It was rated for 14 MPa and because it was vented to atmosphere, it was believed that the risk of an overpressure event was low.

View of where blowback piping (red circle) and fitting (white arrow and star) landed on south side of site.

- The blow-down procedure was modified to step down the pressure from the high-pressure test before going to the blowback piping.
- A pressure transducer was installed on the blowback piping to monitor the line pressure. This has since indicated that overpressure events were likely occurring frequently.
- A pressure safety valve was installed on the blowback piping.
- Piping restraints were added to the blowback lines.
- Equipment layout was modified to shield the manifold operator from the blowback piping.
