# Broken Boom Block Pin Discovered

## Safety Alert

Issue #:02-2017

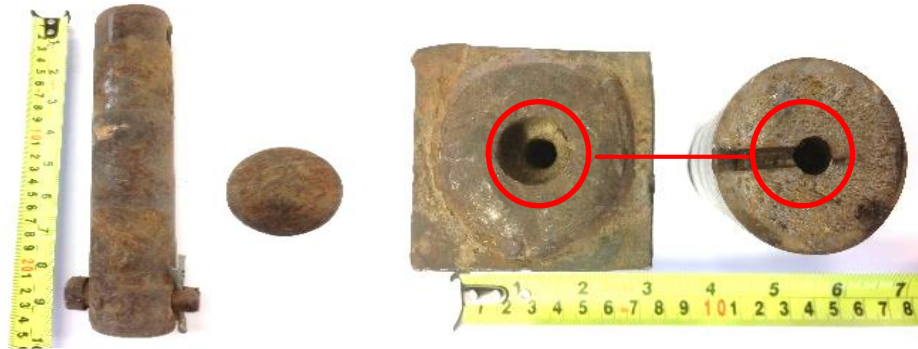
During a pipeline construction project, half of a broken pipelayer pin was located on the ground at the worksite. After locating the appropriate pipelayer, it was determined that a pin from a 572 pipelayer had been used in the place of the appropriate 583 pin.

The pin for 572 pipelayers have a hollow grease channel through the pin, therefore operate at a lower capacity. As a result, the pin broke at some point during the operation of the 583 pipelayer. Both 572 and 583 pipelayers use the same diameter pin and can be easily confused. The pin for the 583 pipelayer is solid throughout. The difference between the two pins is not common knowledge and operators were not inspecting their equipment to confirm pin types.

View of 583 pin type

View of 572 pin type

- All pipelayers were inspected and confirmed to have the correct pins
- Equipment managers were notified and educated on pin differences
- Internal alert was issued and shared
- Follow up was conducted to confirm that all equipment had been inspected
