Storage tank becomes brittle and cracks

Description:

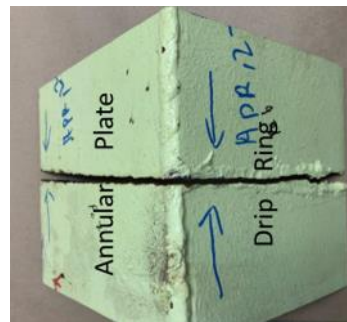
During a visual inspection of a product storage tank, a trace of solidified product was identified, indicating a crack along the drip ring and the annular bottom plate. The tank specification called for the steel to have a minimum design metal temperature (MDMT) of -40 C but the material became brittle at lower temperatures (-15 C and below), resulting in a crack.

Failed annular bottom plate

- Ensure that any steel material tank substitutions are risk assessed in relation to MDMT as part of a management of change process.
- Material vendors and supply chain teams must communicate clearly and in detail about material specifications and design requirements.
- Use the tools provided in the international standards (charts, grades of metals, etc.) to ensure material specifications are met.
- Always consider the impact of temperature variability in the selection or substitution of materials.
