# Kick Out Pin Failure

## Safety Alert

Issue #:03-2017

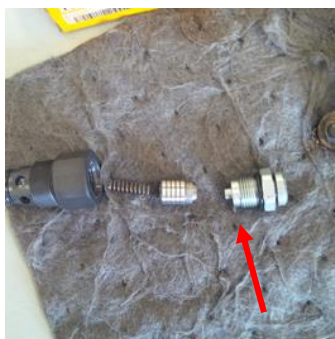
During the investigation it was found that the kick out pin was only functional at low idle. The kick out pin was not functioning at high idle, because the orifice on the main valve regulating the flow of hydraulic fluid to the kick out pin was rebuilt improperly. In addition, the boom line control lever remained stuck in the engaged position because the bolts on the lever caught on the control panel.

The orifice was rebuilt in the improper order, as it was installed in the main valve.

- Previous servicing of the unit left the main valve orifice installed incorrectly, rendering the kick out inoperative with the throttle over idle.
- The operator did not ensure that the boom line control lever was in neutral prior to moving.

- All sidebooms in the fleet that had the same hydraulic system were tested for proper kick out response at low and high idle.
- The control levers were tested for the sticking malfunction on all sidebooms and repaired as required.
- Secondary hydraulic or electric bypass systems to disable the boom system will be investigated.

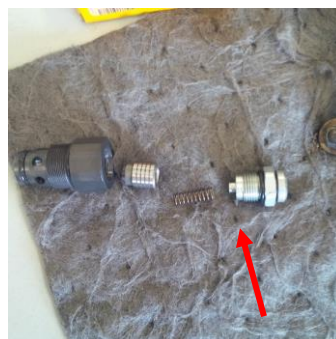
The proper order for the orifice to be assembled for use. Note location of the spring.

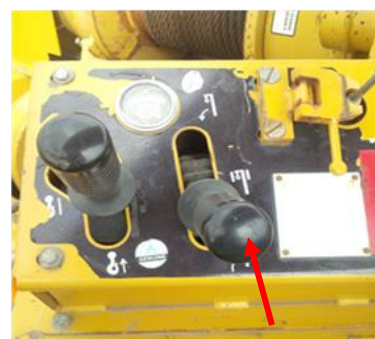
The boom stick control lever stuck in the engaged position.
