Industry-Submitted Notification

Incident: Casing Running Tool (CRT) dropped to rig floor striking worker.

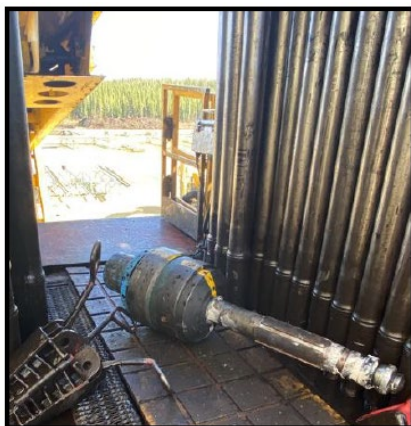
Approximately 4 hours later, while running casing, the CRT became disconnected at the connection point between the CRT and the CRT crossover. The CRT weighing approximately 760 lbs. fell approximately 15 meters fatally injuring a third-party worker on the rig floor.

- Verify that the crossover for the CRT is torqued to the recommended specifications.
- Visual confirmation - A chalk line or paint line should be placed on all connections above the CRT as a visual for the connection. Visually inspect chalk lines with cameras or at regular inspection intervals.

- Engage CRT and perform pre-job pull /torque test as outlined in the JSA. After releasing the CRT from the pull/torque test, visually inspect chalk/paint line on overhead connections to ensure no movement has occurred.

- Equipment Design or Installation: Install anti-rotation device to prevent unexpected tool joint backoff of the crossover or tether system to prevent drop incident when CRT is being used intermittently.
