# COILED TUBING UNIT STAIR FAILURE INJURY

## DESCRIPTION:

A worker performing maintenance on a coiled tubing unit fell while exiting the control cabin when the stairs became detached. The worker was seriously injured in the fall.

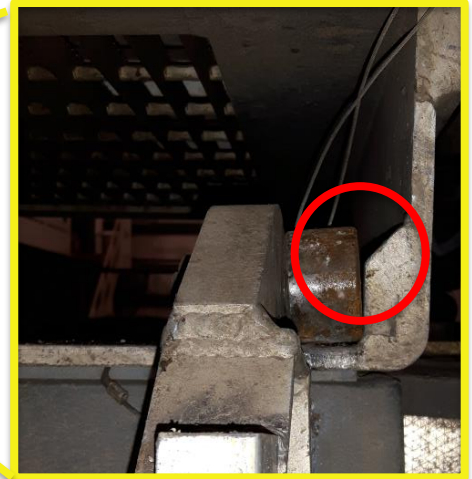
The stair stops, or “ears”, on the stow box are expected to hold the roller in place while in use. Note the roller is not secured behind the stair stops (red circle).

The stops holding the stairs in position did not hold. The stair stops “ears” were slightly bent, allowing the stairs to escape the tracks.

The original design of the stairs did not prevent this occurrence. It allowed movement within the stair roller and stop, which ultimately failed when worker exited the control cabin and stepped onto the stairs.

- The company inspected all stairs on other coil tubing units and developed a permanent modification with the original equipment manufacturer
- Check stairs periodically to ensure they are secured and not damaged

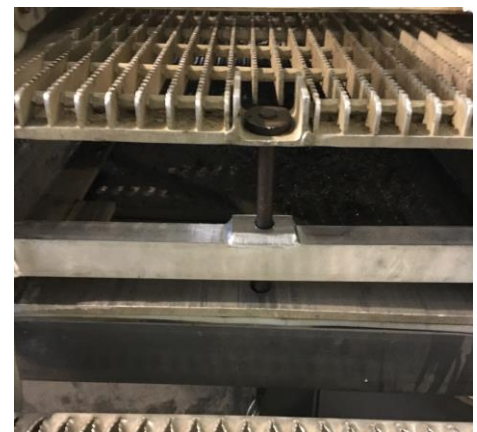
Engineered solution for step securement
