# WORKER INJURED DURING HYDRO-VAC OPERATIONS

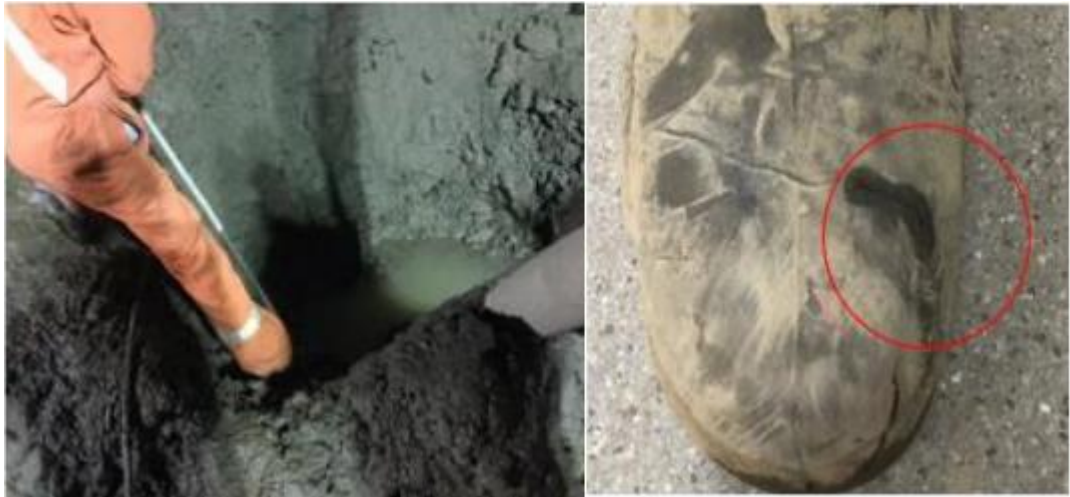
A worker excavating frozen soil using a seven-foot straight tip wand, received a surface laceration and minor burn to the top of the foot. The worker's right foot became stuck in mud, causing the worker to stumble and move the wand on top of his foot. The high-pressure water cut the boot above the protective steel toe.

1 - WORKER LOST FOOTING (LEFT). 2 - WORKERS RUBBER BOOT AFTER IMPACT (RIGHT)

The worker was wearing rubber steel toe boots that did not provide adequate protection from the hot, high pressure water (65°C at 2000 PSI).

The wand was not equipped with a handle for proper hand placement and did not have a shut-off valve.

- » Communicate to hydro-vac contractors the need for metatarsal foot protection when using a straight tip wand
- » Hydro-vac contractors should use wands with handles that provide adequate grip and a method to stop the flow of water at the wand
- » Owners, prime contractors and employers should assess each scope of work for its specific hazards; ensure proper communication to the work force when changing conditions require specialized personal protective equipment
