# TANK CRADLE ARM FAILURE

## DESCRIPTION:

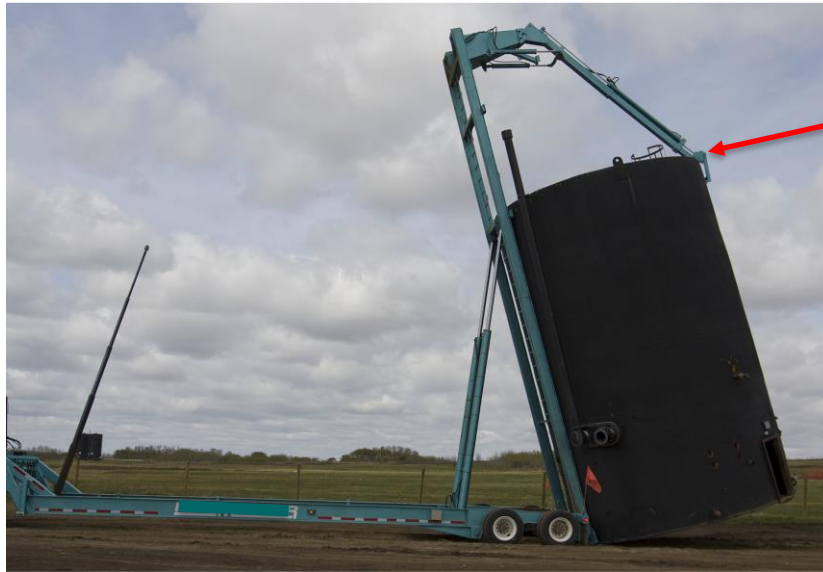
**Example of a tank cradle arm with the bracket intact**

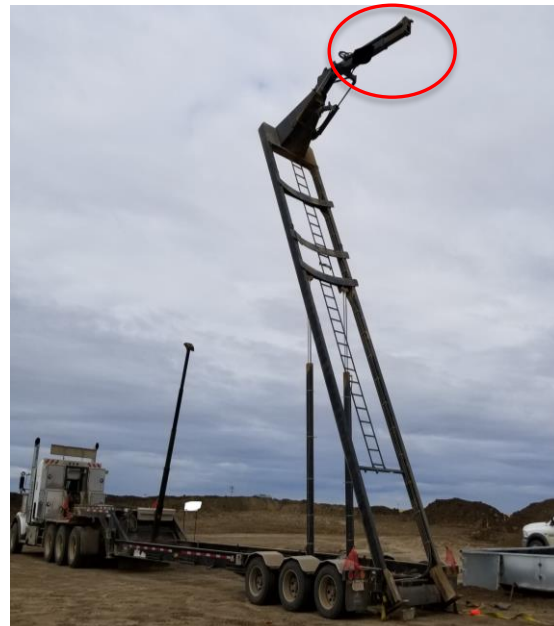
A 1,000-barrel tank was being moved into place when the cradle arm bracket failed. The bracket was held in place by the main mast pin, which was secured with a cotter pin. The cotter pin broke, allowing the main mast pin to slide out of place. As a result, the tank slid off the cradle, fell to the ground, and landed on its side, damaging the tank. No injuries occurred.

**The main mast pin slid out of the bracket**

**Failed bracket at the top of the tank cradle arm**

The cotter pin was either not put in place correctly, or shifted during the move.

- No previous inspection records were available
- Equipment was not visually inspected prior to use
- Cotter pins used in this application are prone to damage while being transported
- The cotter pin used may not have been made from the correct material for the equipment

- Revise existing policies/procedures to include specific equipment inspection points prior to use
- Cotter pin holding the main mast should be replaced with a grade 8 capture pin  
(Note: the manufacturer of the equipment has not suggested an upgrade to the cotter pin design, however, it is possible that without frequent inspections of the current cotter pin design, this failure could happen again)

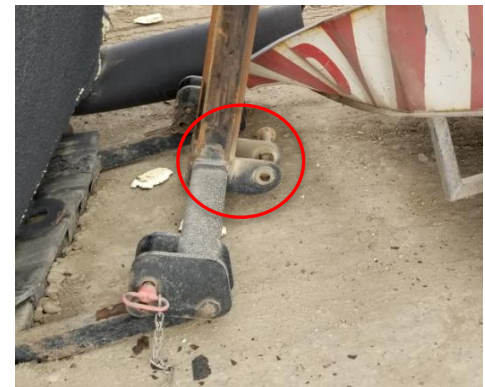
**Close-up of the failed bracket with the Main mast pin out of position**
