VAC TRUCK HINGE PIN FAILURE

DESCRIPTION:

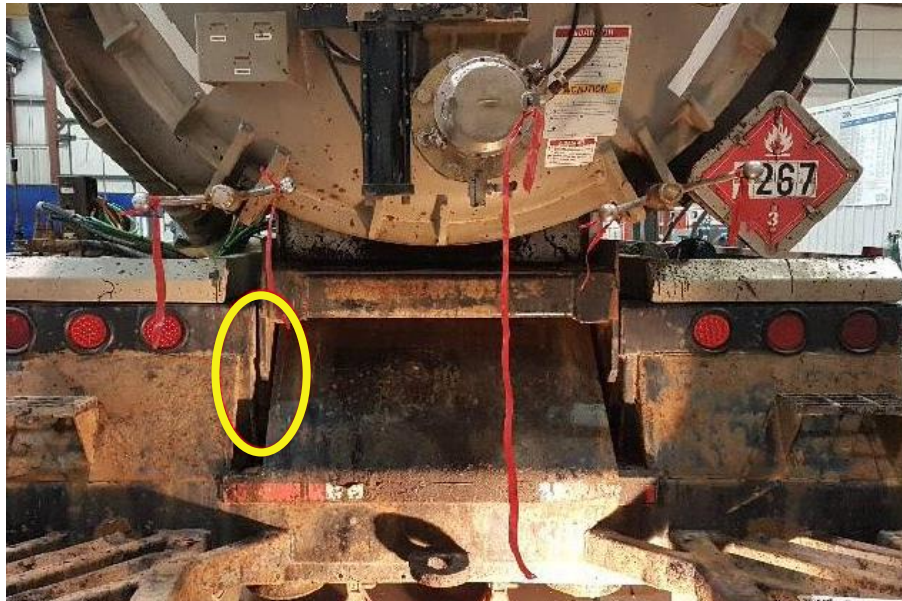
During a vacuum truck inspection the rear tank hinge pin was found to be sheared. Under slightly different circumstances, this could have resulted in catastrophic failure of tank securement. Additional weight or the dumping of fluids could have led to the entire vessel falling off the body of the truck.

Location of sheared hinge pin

Road debris accumulation, fluid spillage, and location of hinge pin resulted in pin failure.

- Buildup of road debris in the hinge pin grease fittings and unprotected location of fittings
- Inspection intervals and greasing frequency

- Company examined all their vacuum trucks of similar design, to ensure hinge pins are inspected and greased.
- Company had engineer re-position of grease points to more protected location.
- Consider reviewing and, if necessary, revising service intervals. Company choose to revise theirs to every 250 hours.

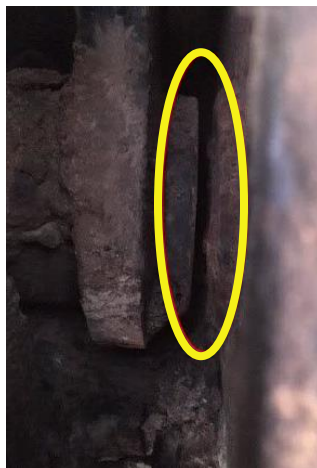
Hinge pin sheared
