The Safety Association for Canada's
Upstream Oil and Gas Industry

Wireline Control Valve Tips Over Onto Worker

Inexperienced worker injured

ISSUE #: 03-2011

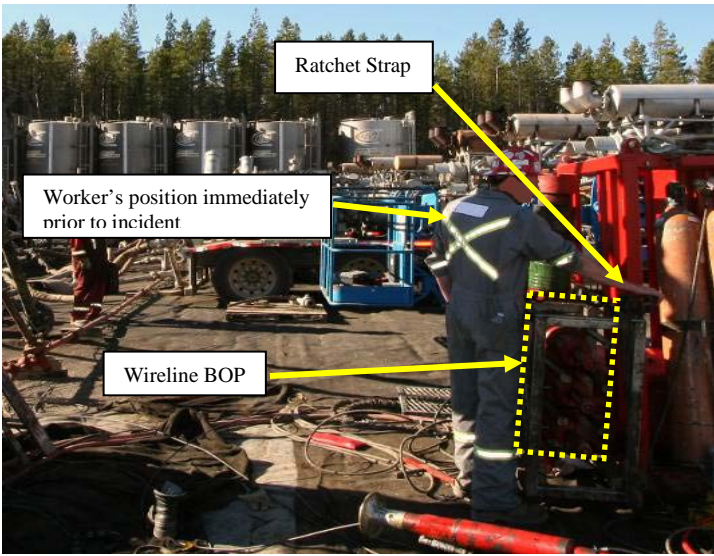
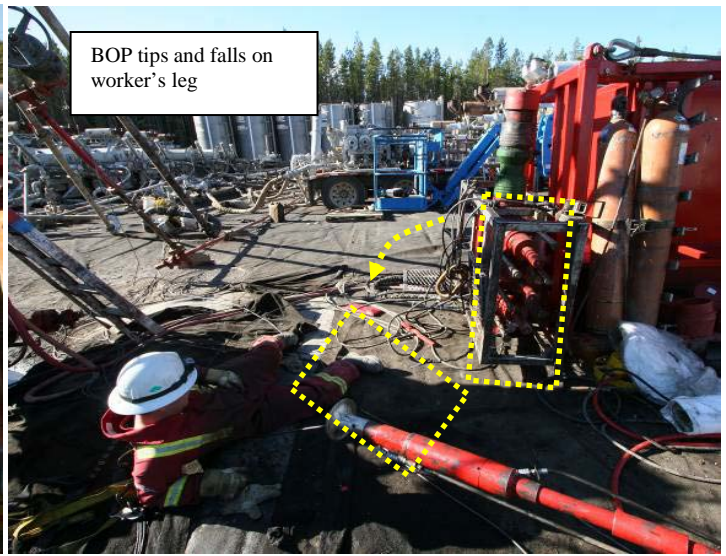
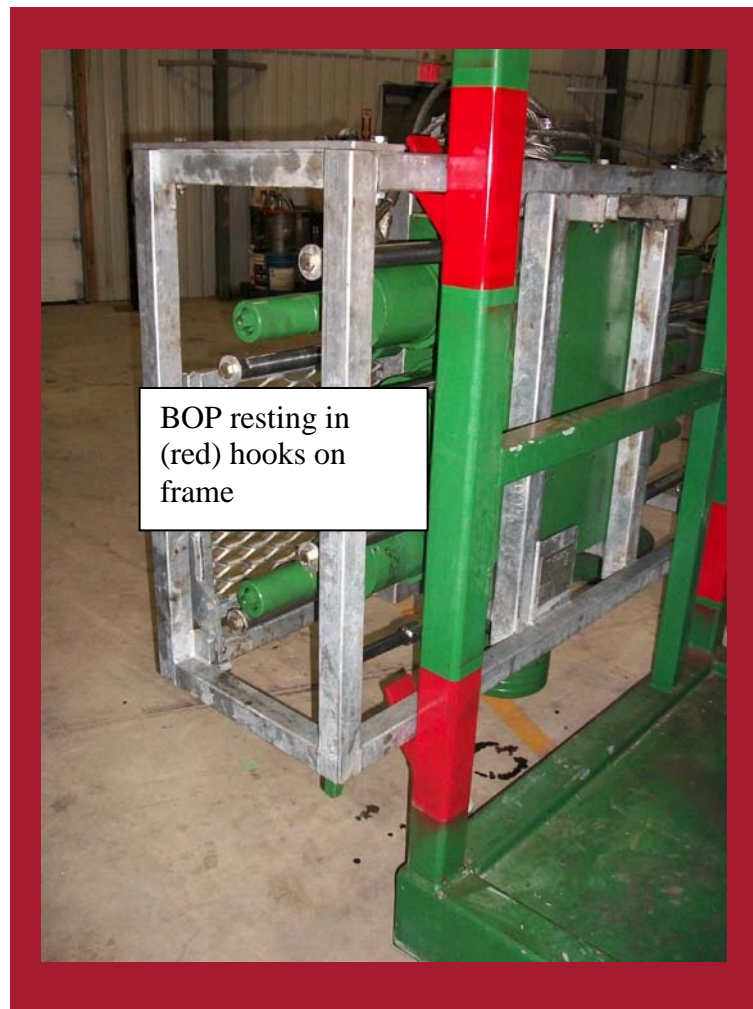
- A wireline crew was preparing to lift a wireline BOP control valve onto the well head.
- The control valve had been secured to a frame structure on the ground by means of two ratchet straps to prevent it from falling over.
- A new worker was assigned the task of hooking the valve to the crane hook by means of a lifting sling.
- The worker was seriously injured, when the wireline control valve fell over and knocked him to the ground.

- The new worker released the straps and then attempted to put the sling into the crane hook.
- The worker did not recognize the risk of putting himself in the path of a potential tip over.

Fixed hooks have since been installed on the frame structure, where the BOP is set into, when it is taken off the wellhead. This engineered solution eliminates the need to use ratchet straps to restrain the BOP while not in use.
